Special Investigation Report
Aircraft Separation Incidents at Hartsfield
Atlanta International Airport, Atlanta, Georgia
October 7, 1980

SPECIAL INVESTIGATION REPORT

**AIRCRAFT SEPARATION INCIDENTS
AT HARTSFIELD ATLANTA INTERNATIONAL AIRPORT
ATLANTA, GEORGIA
OCTOBER 7, 1980**

NTSB-SIR-81-6

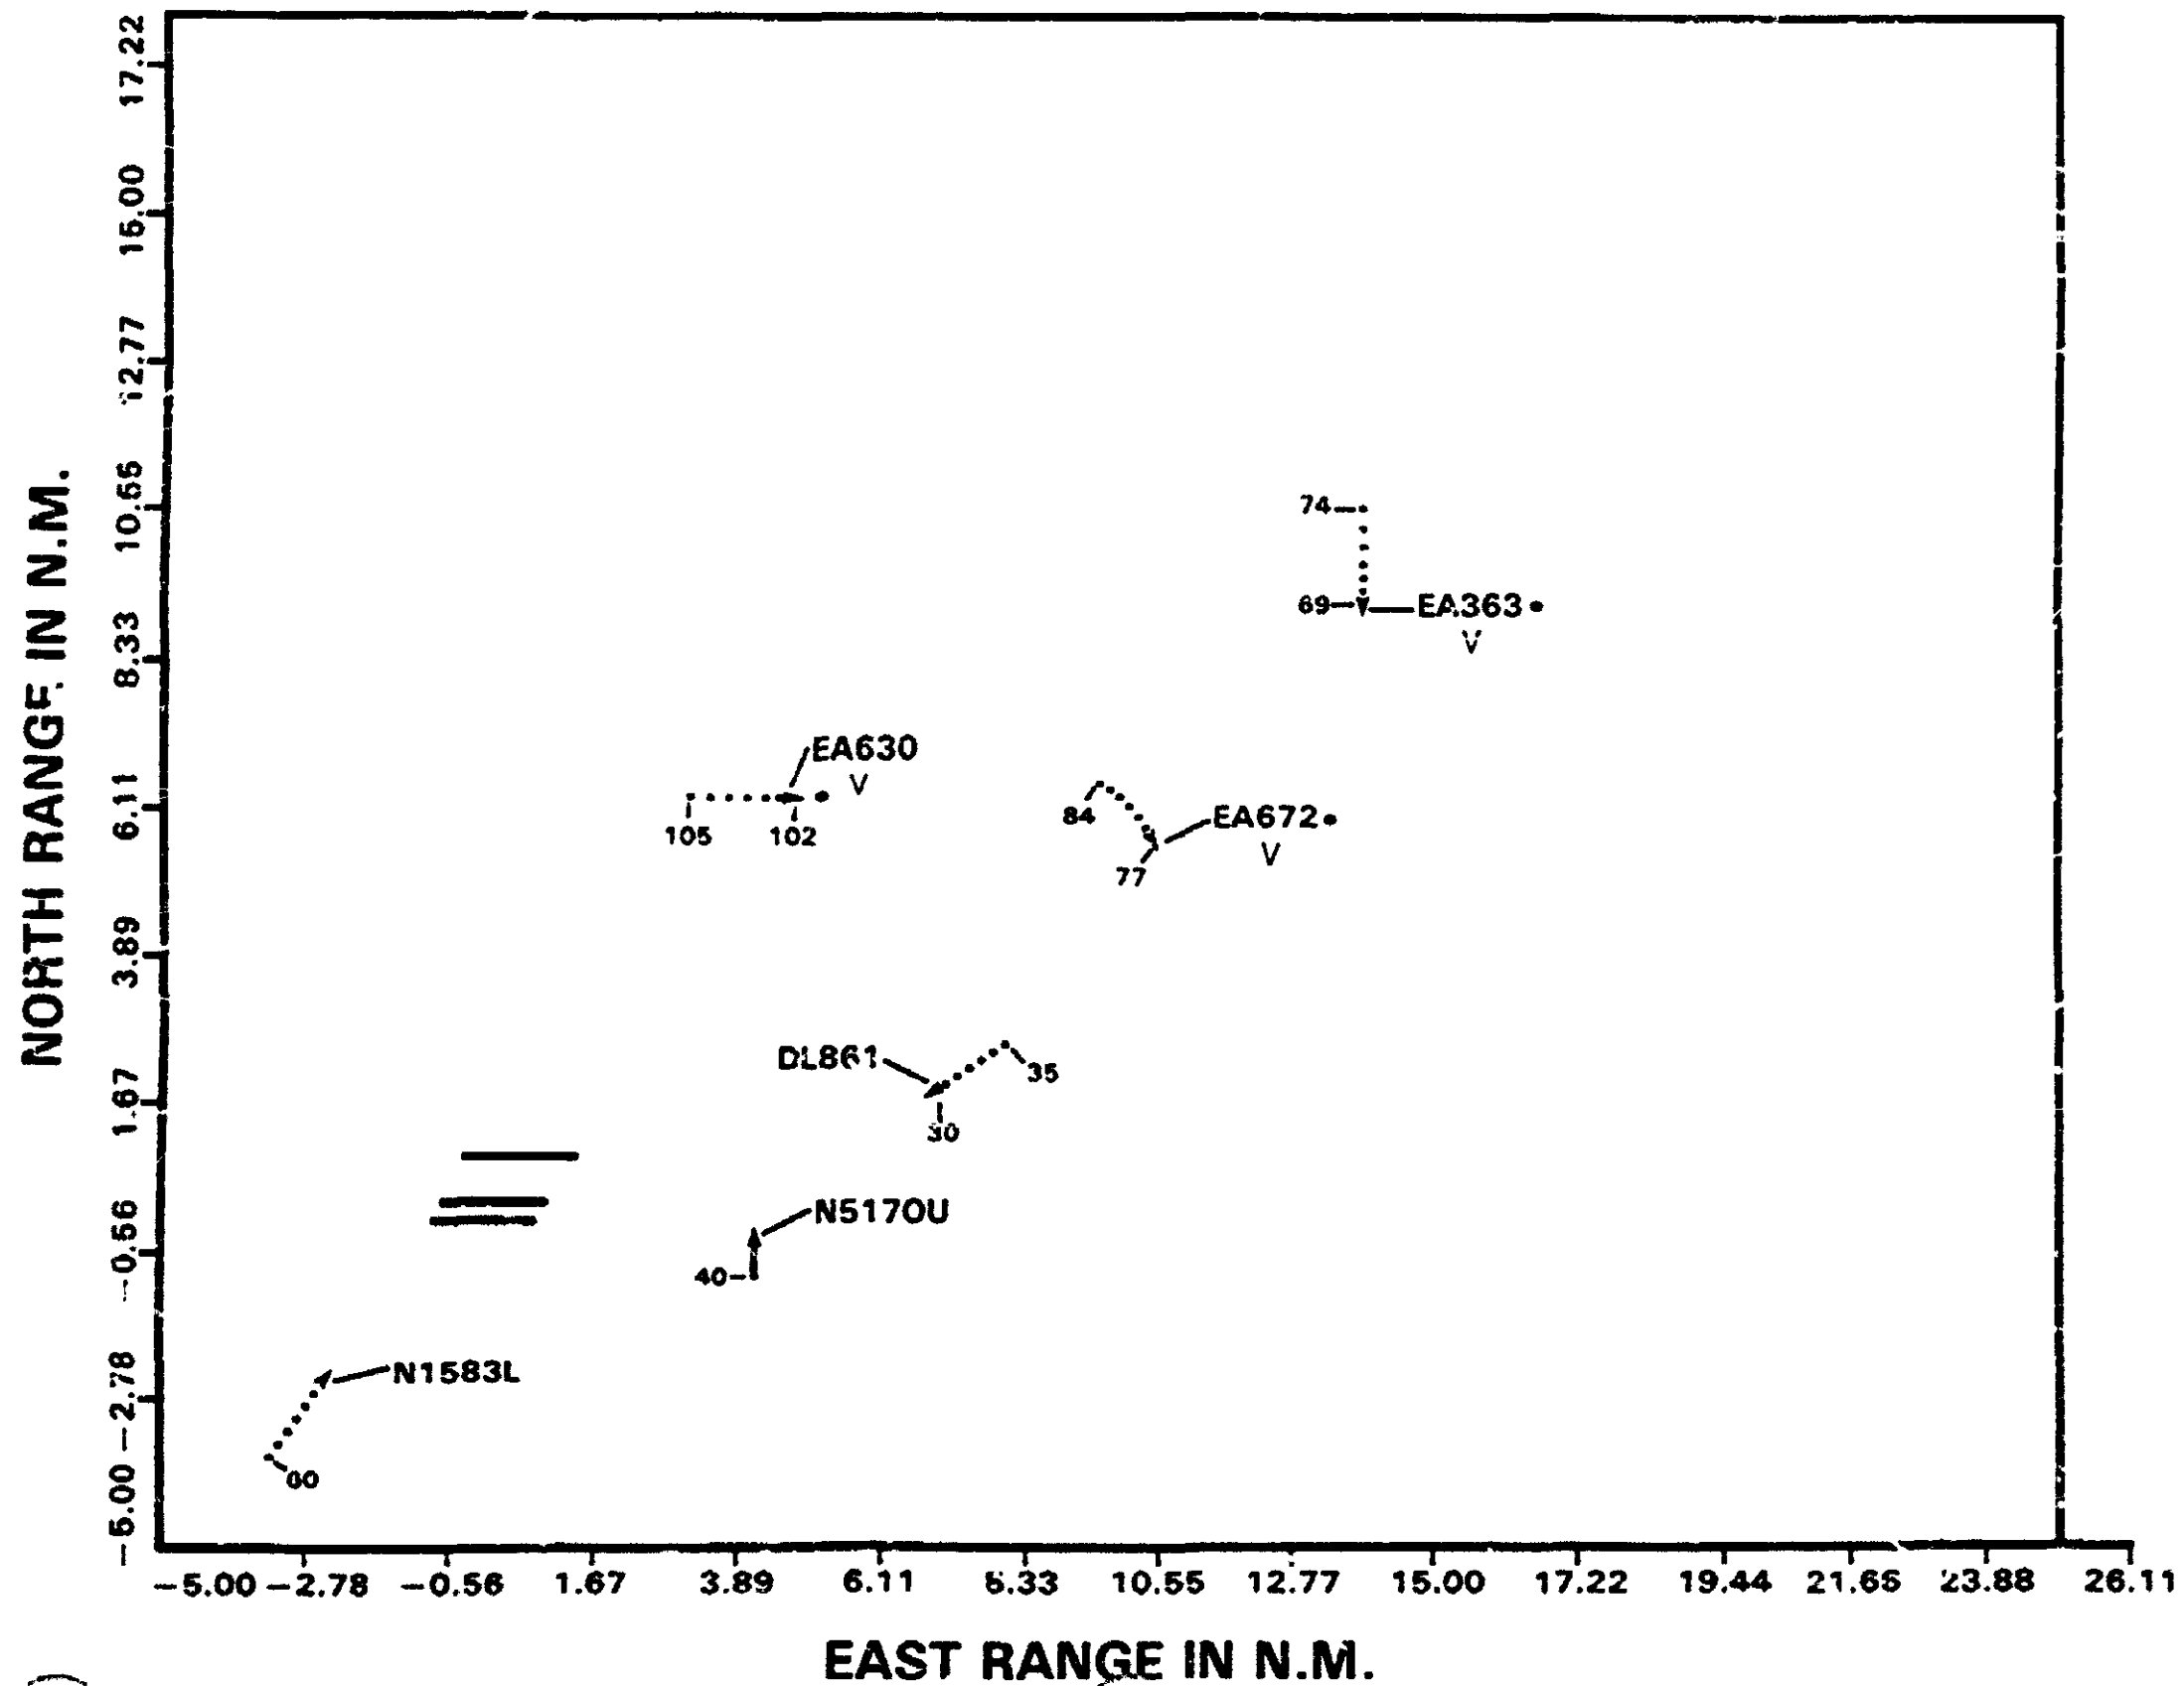
08:08:30.0-08:09:00.0

The relative speeds of the aircraft should be noted. Note the distance between each "hit" of the radar for N517OU, N1583L, and EA672. The total distance traveled for these three aircraft in the 30-sec time period should be noted. N517OU's speed appears to be about 1/2 that of EA672 and N1583L.

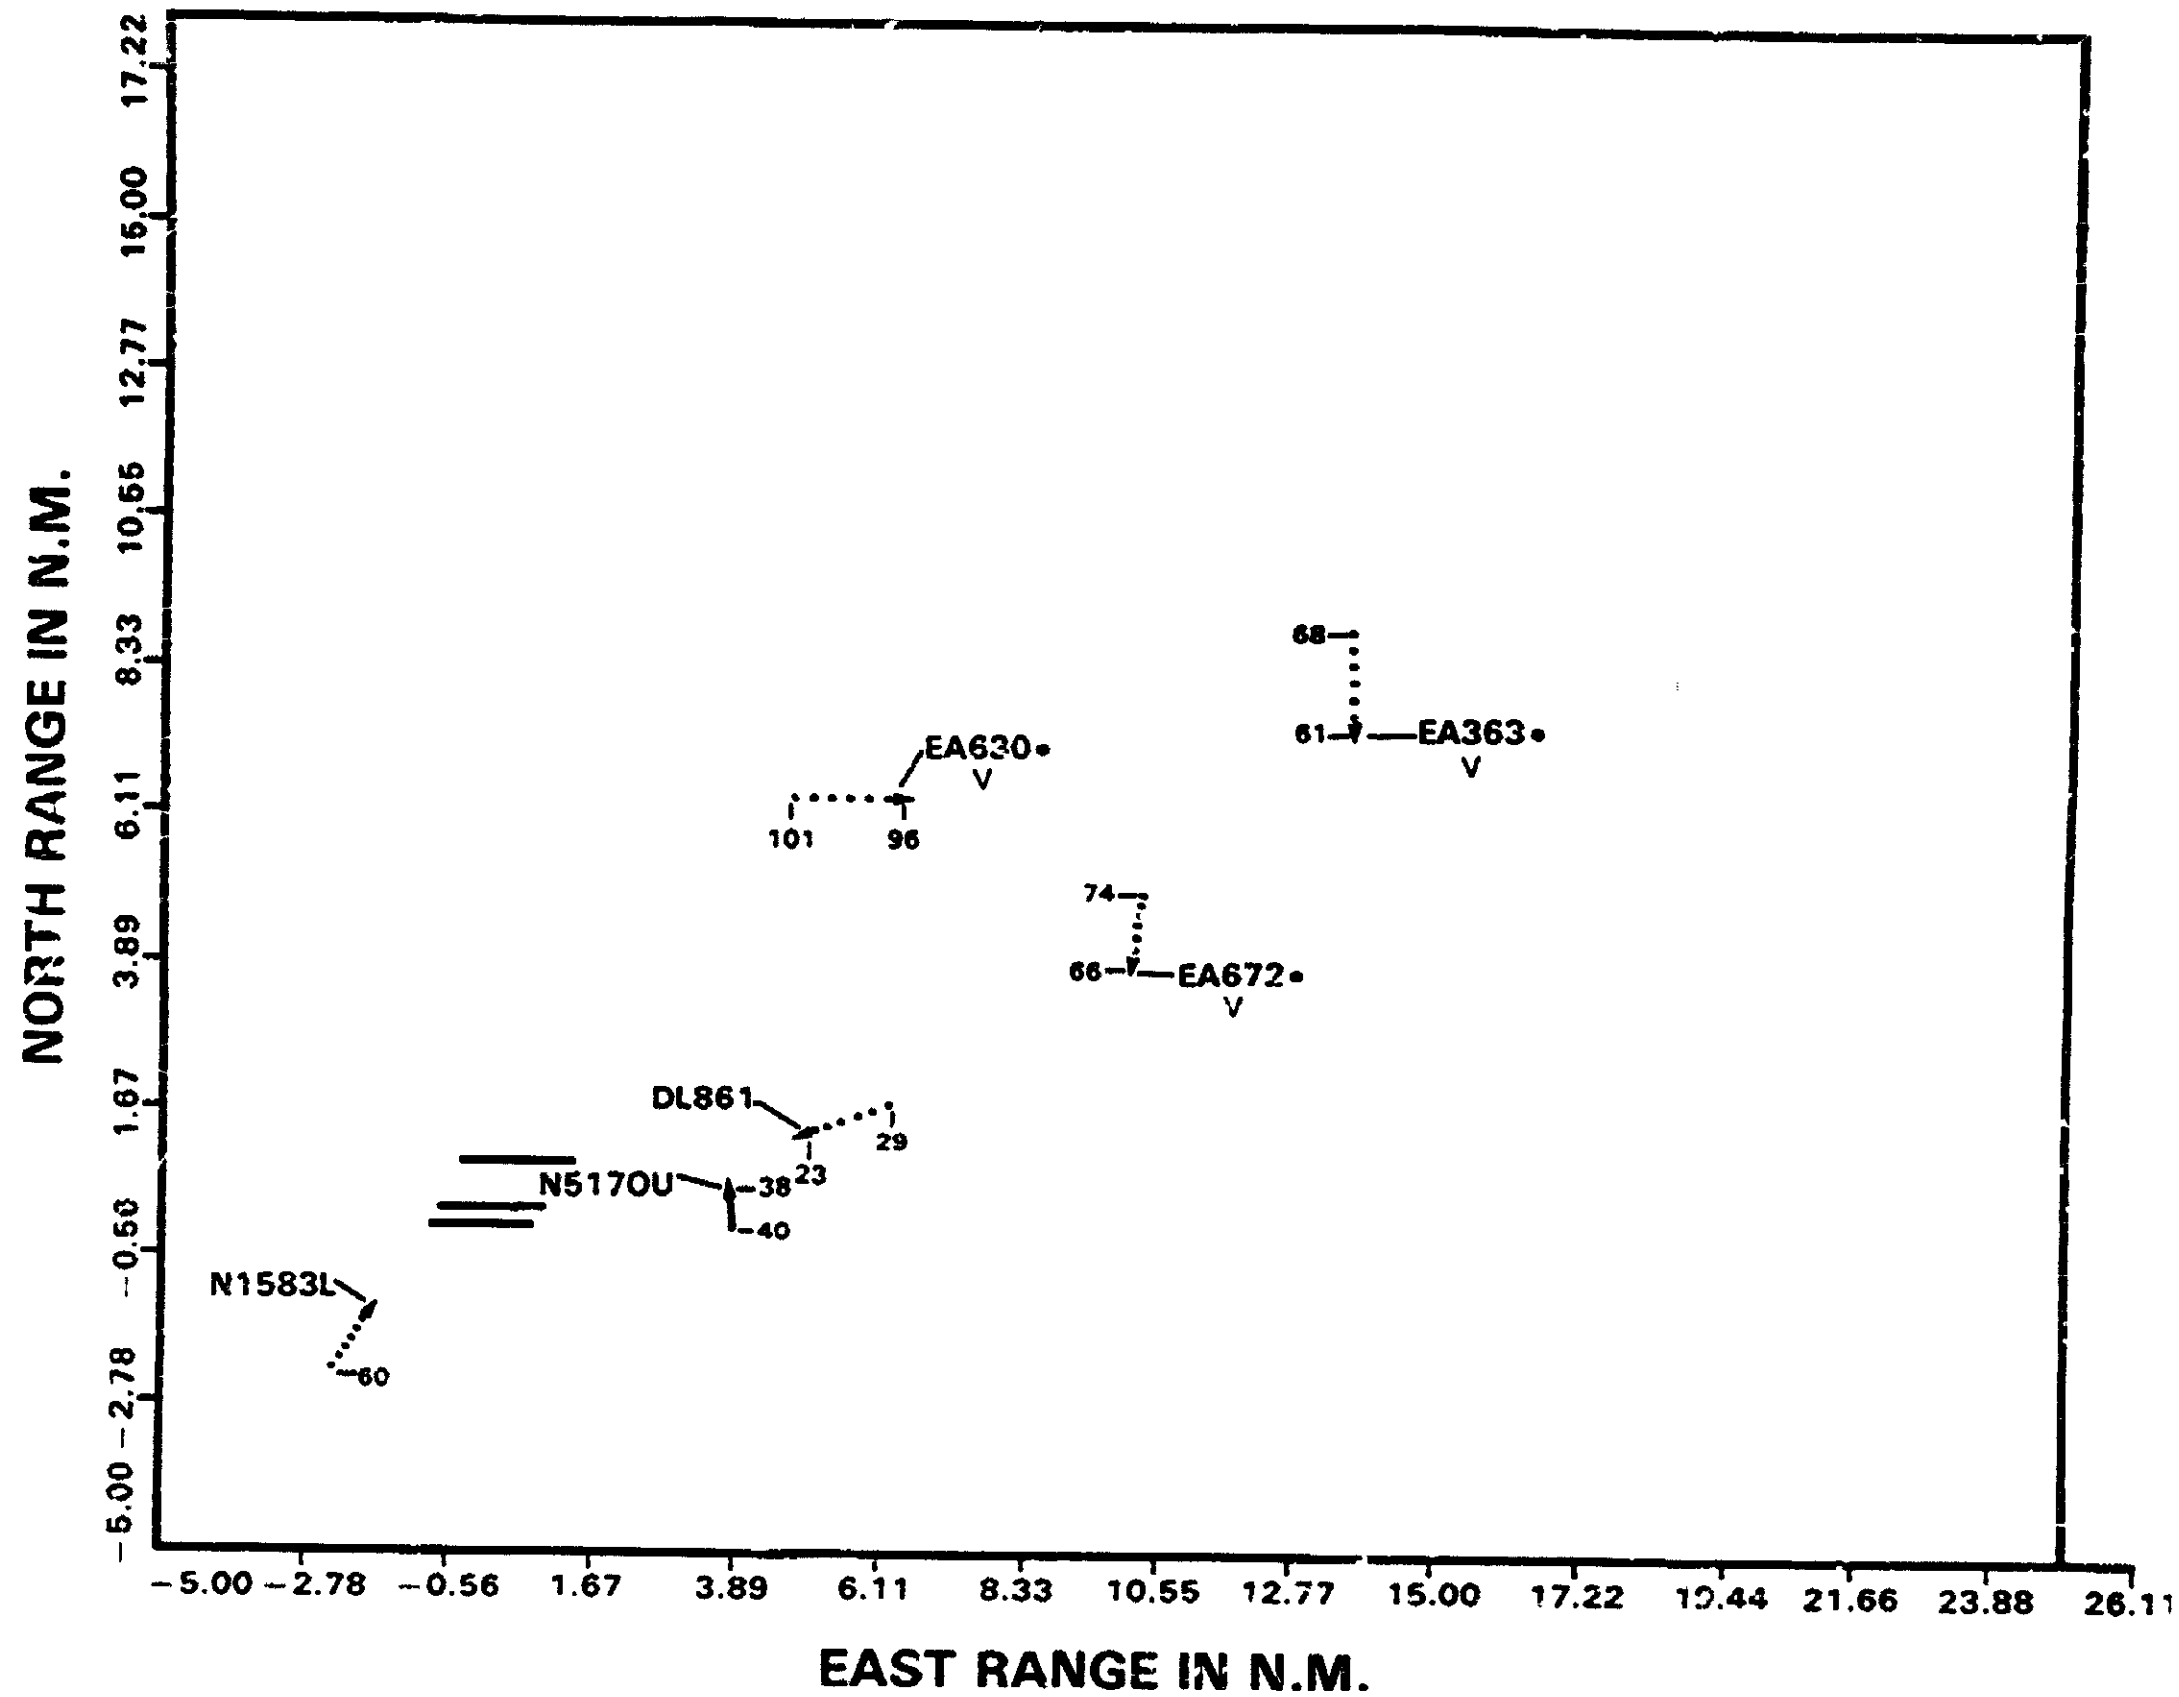
08:09:00.0-08:09:30.0

EA363 is being brought into the pattern on the base leg, to be followed by EA630.

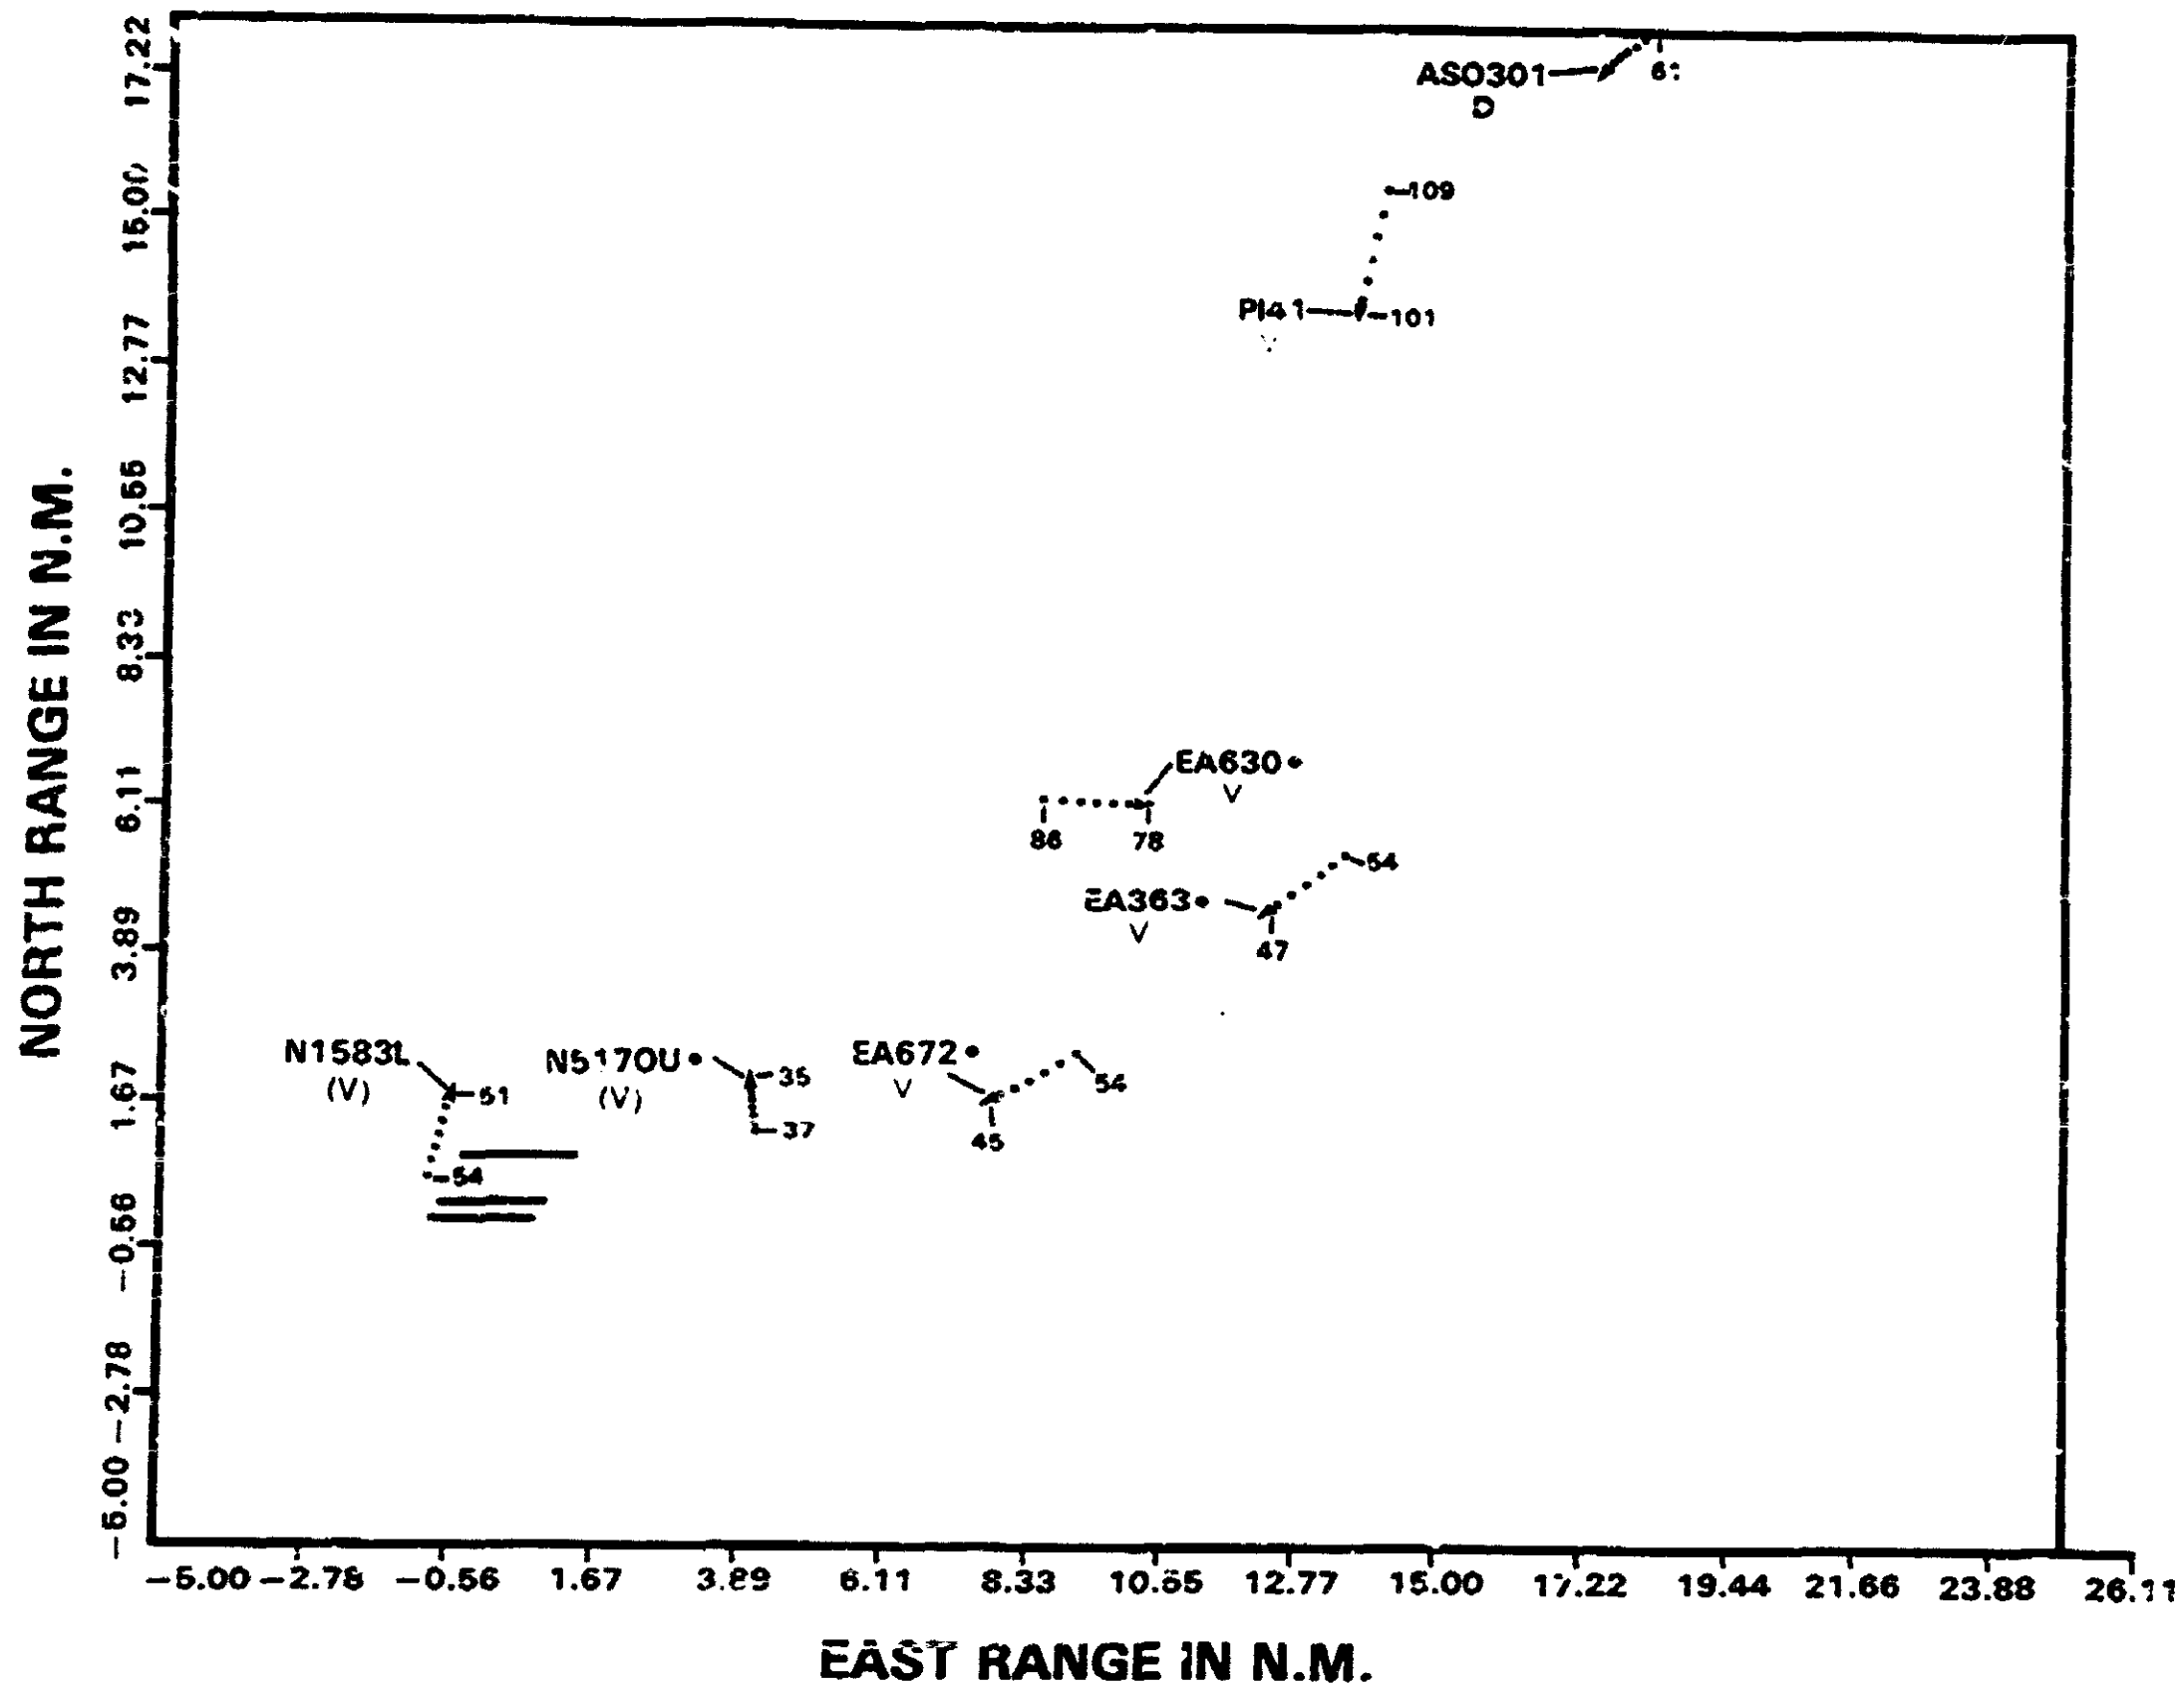
08:10:00.0-08:10:30.0

Eastern 363 confirmed that he saw his traffic. The symbols "V" located under the aircraft identification indicate that the "final" controller has accepted control of the aircraft. Aircraft still under control of the "feeder" controller is designated with a "D."

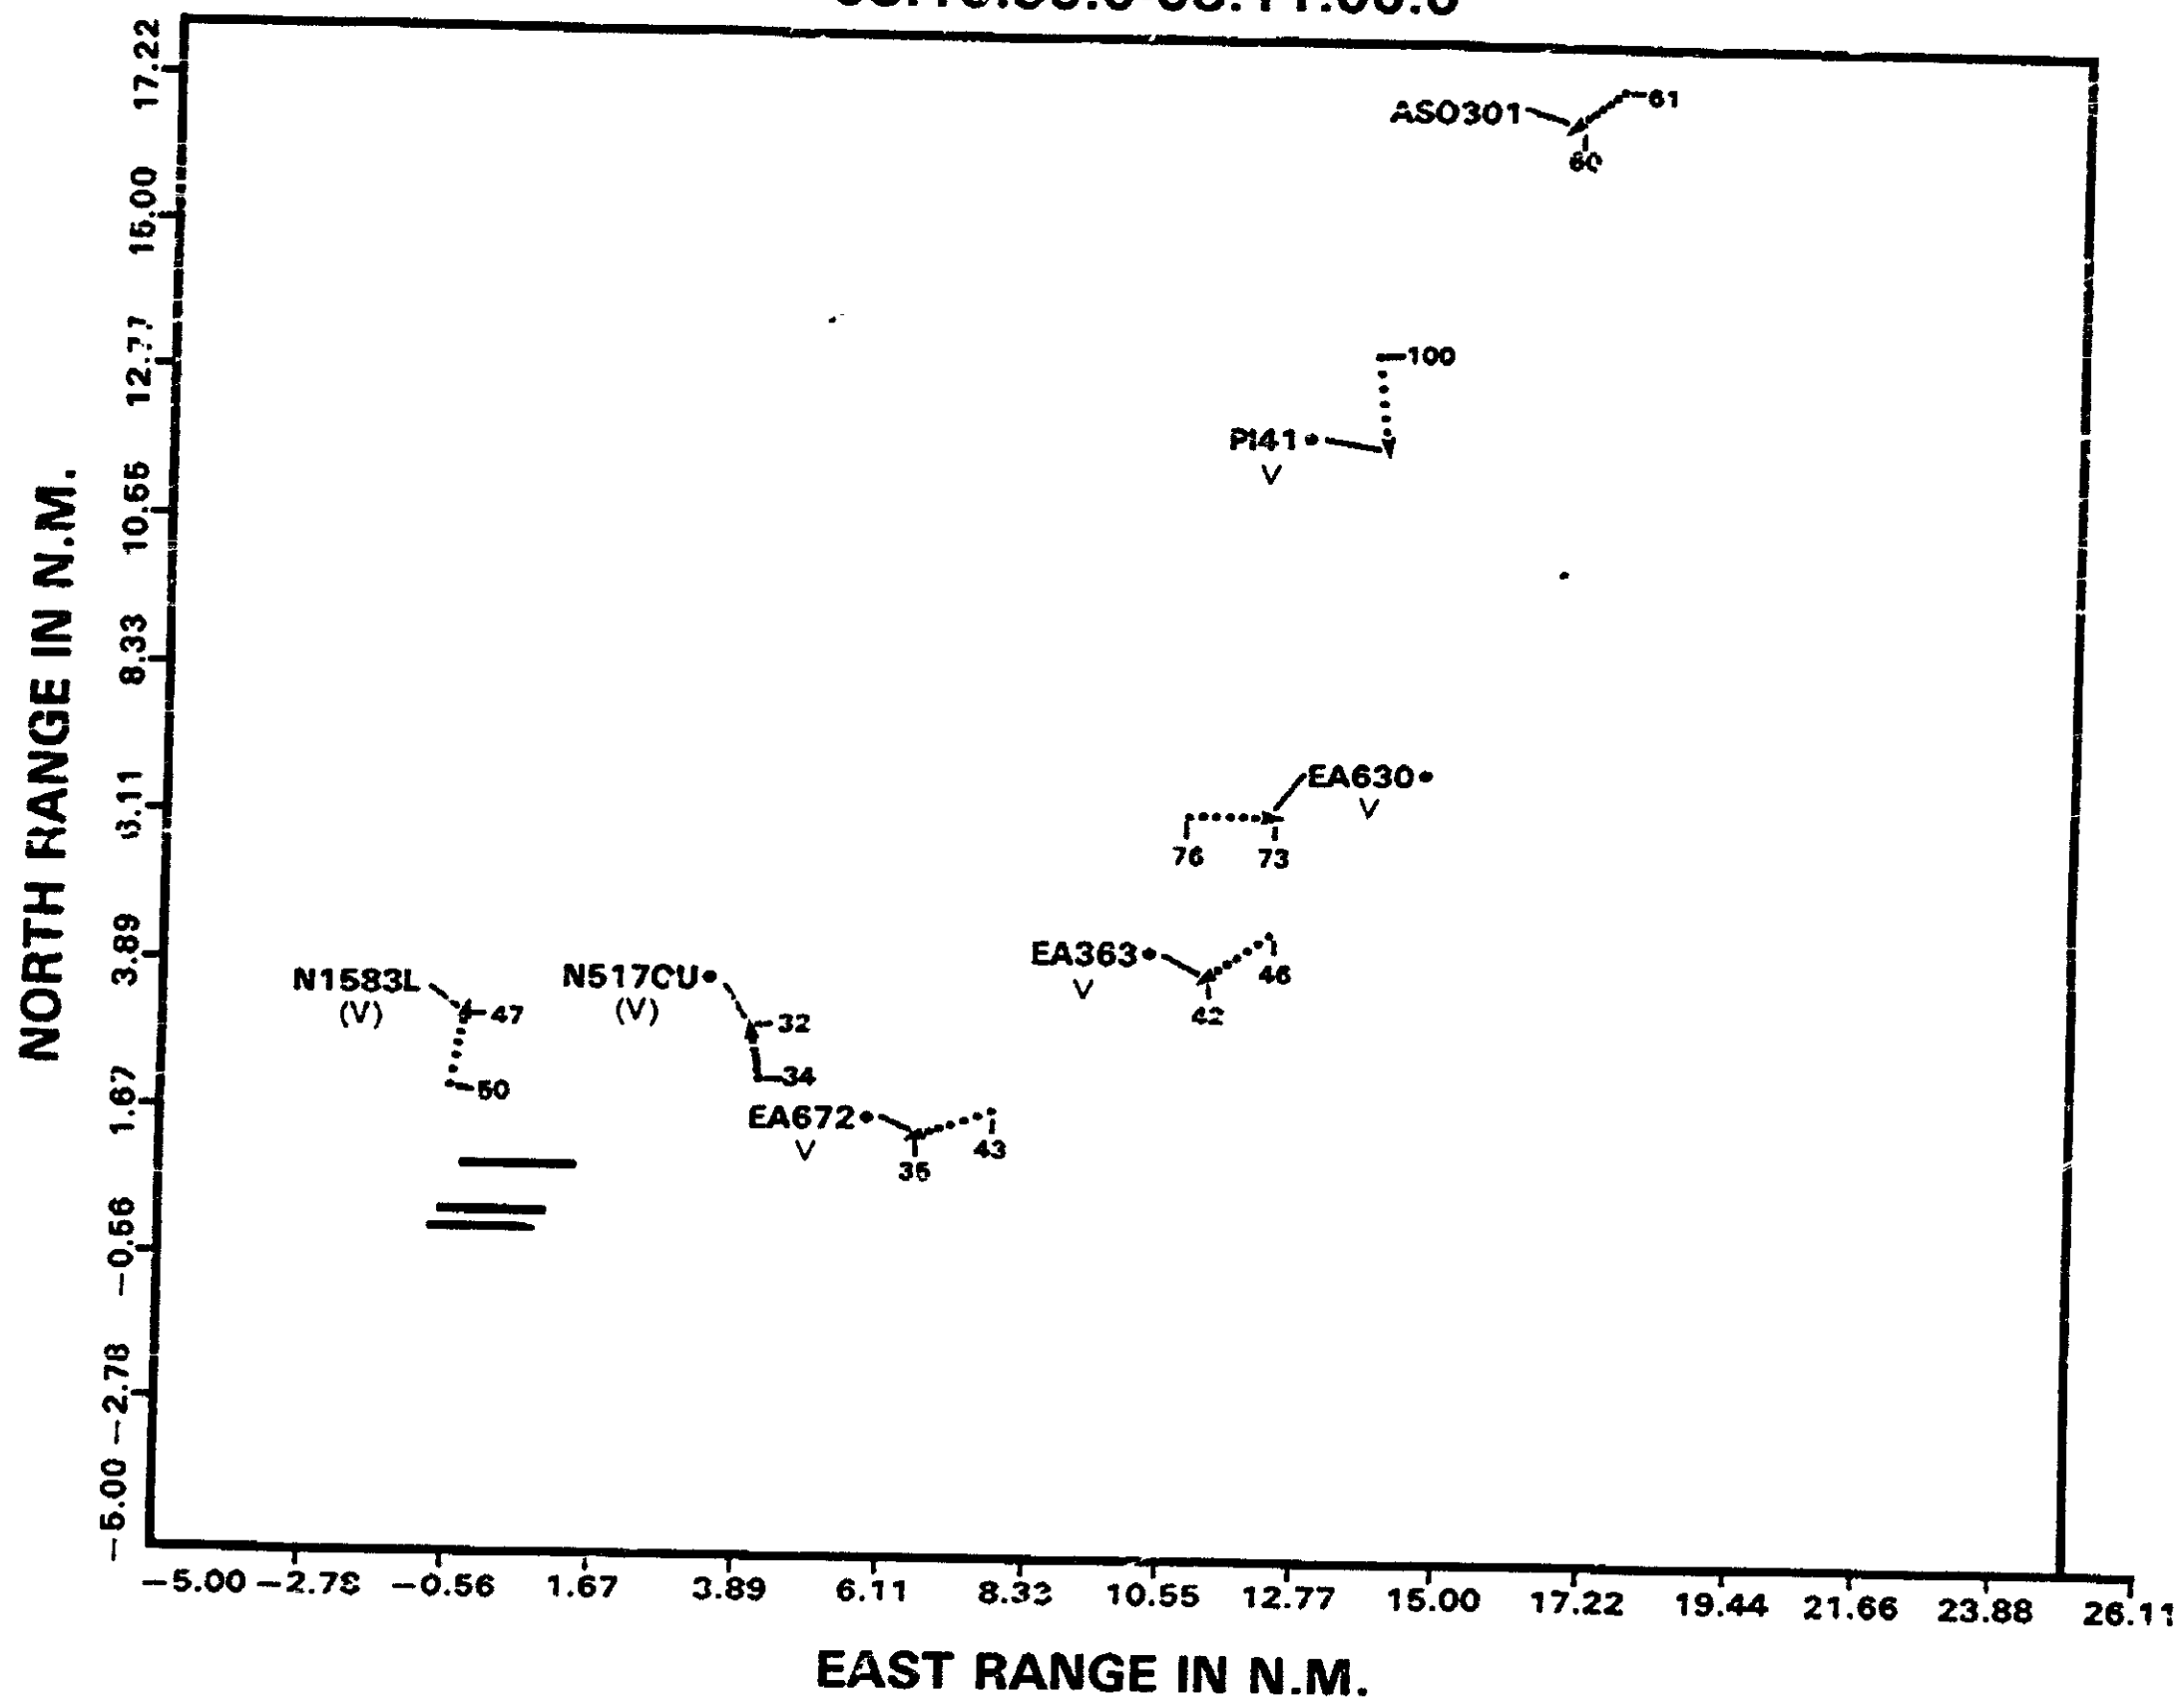
08:10:30.0-08:11:00.0

The conversation here between the "V" and "N" controllers shows that the "N" controller was assuring separation between N1583L and N5170U before instructing N5170U to change frequency.

The final controller accepts the handoff of ASO301 from the feeder controller.

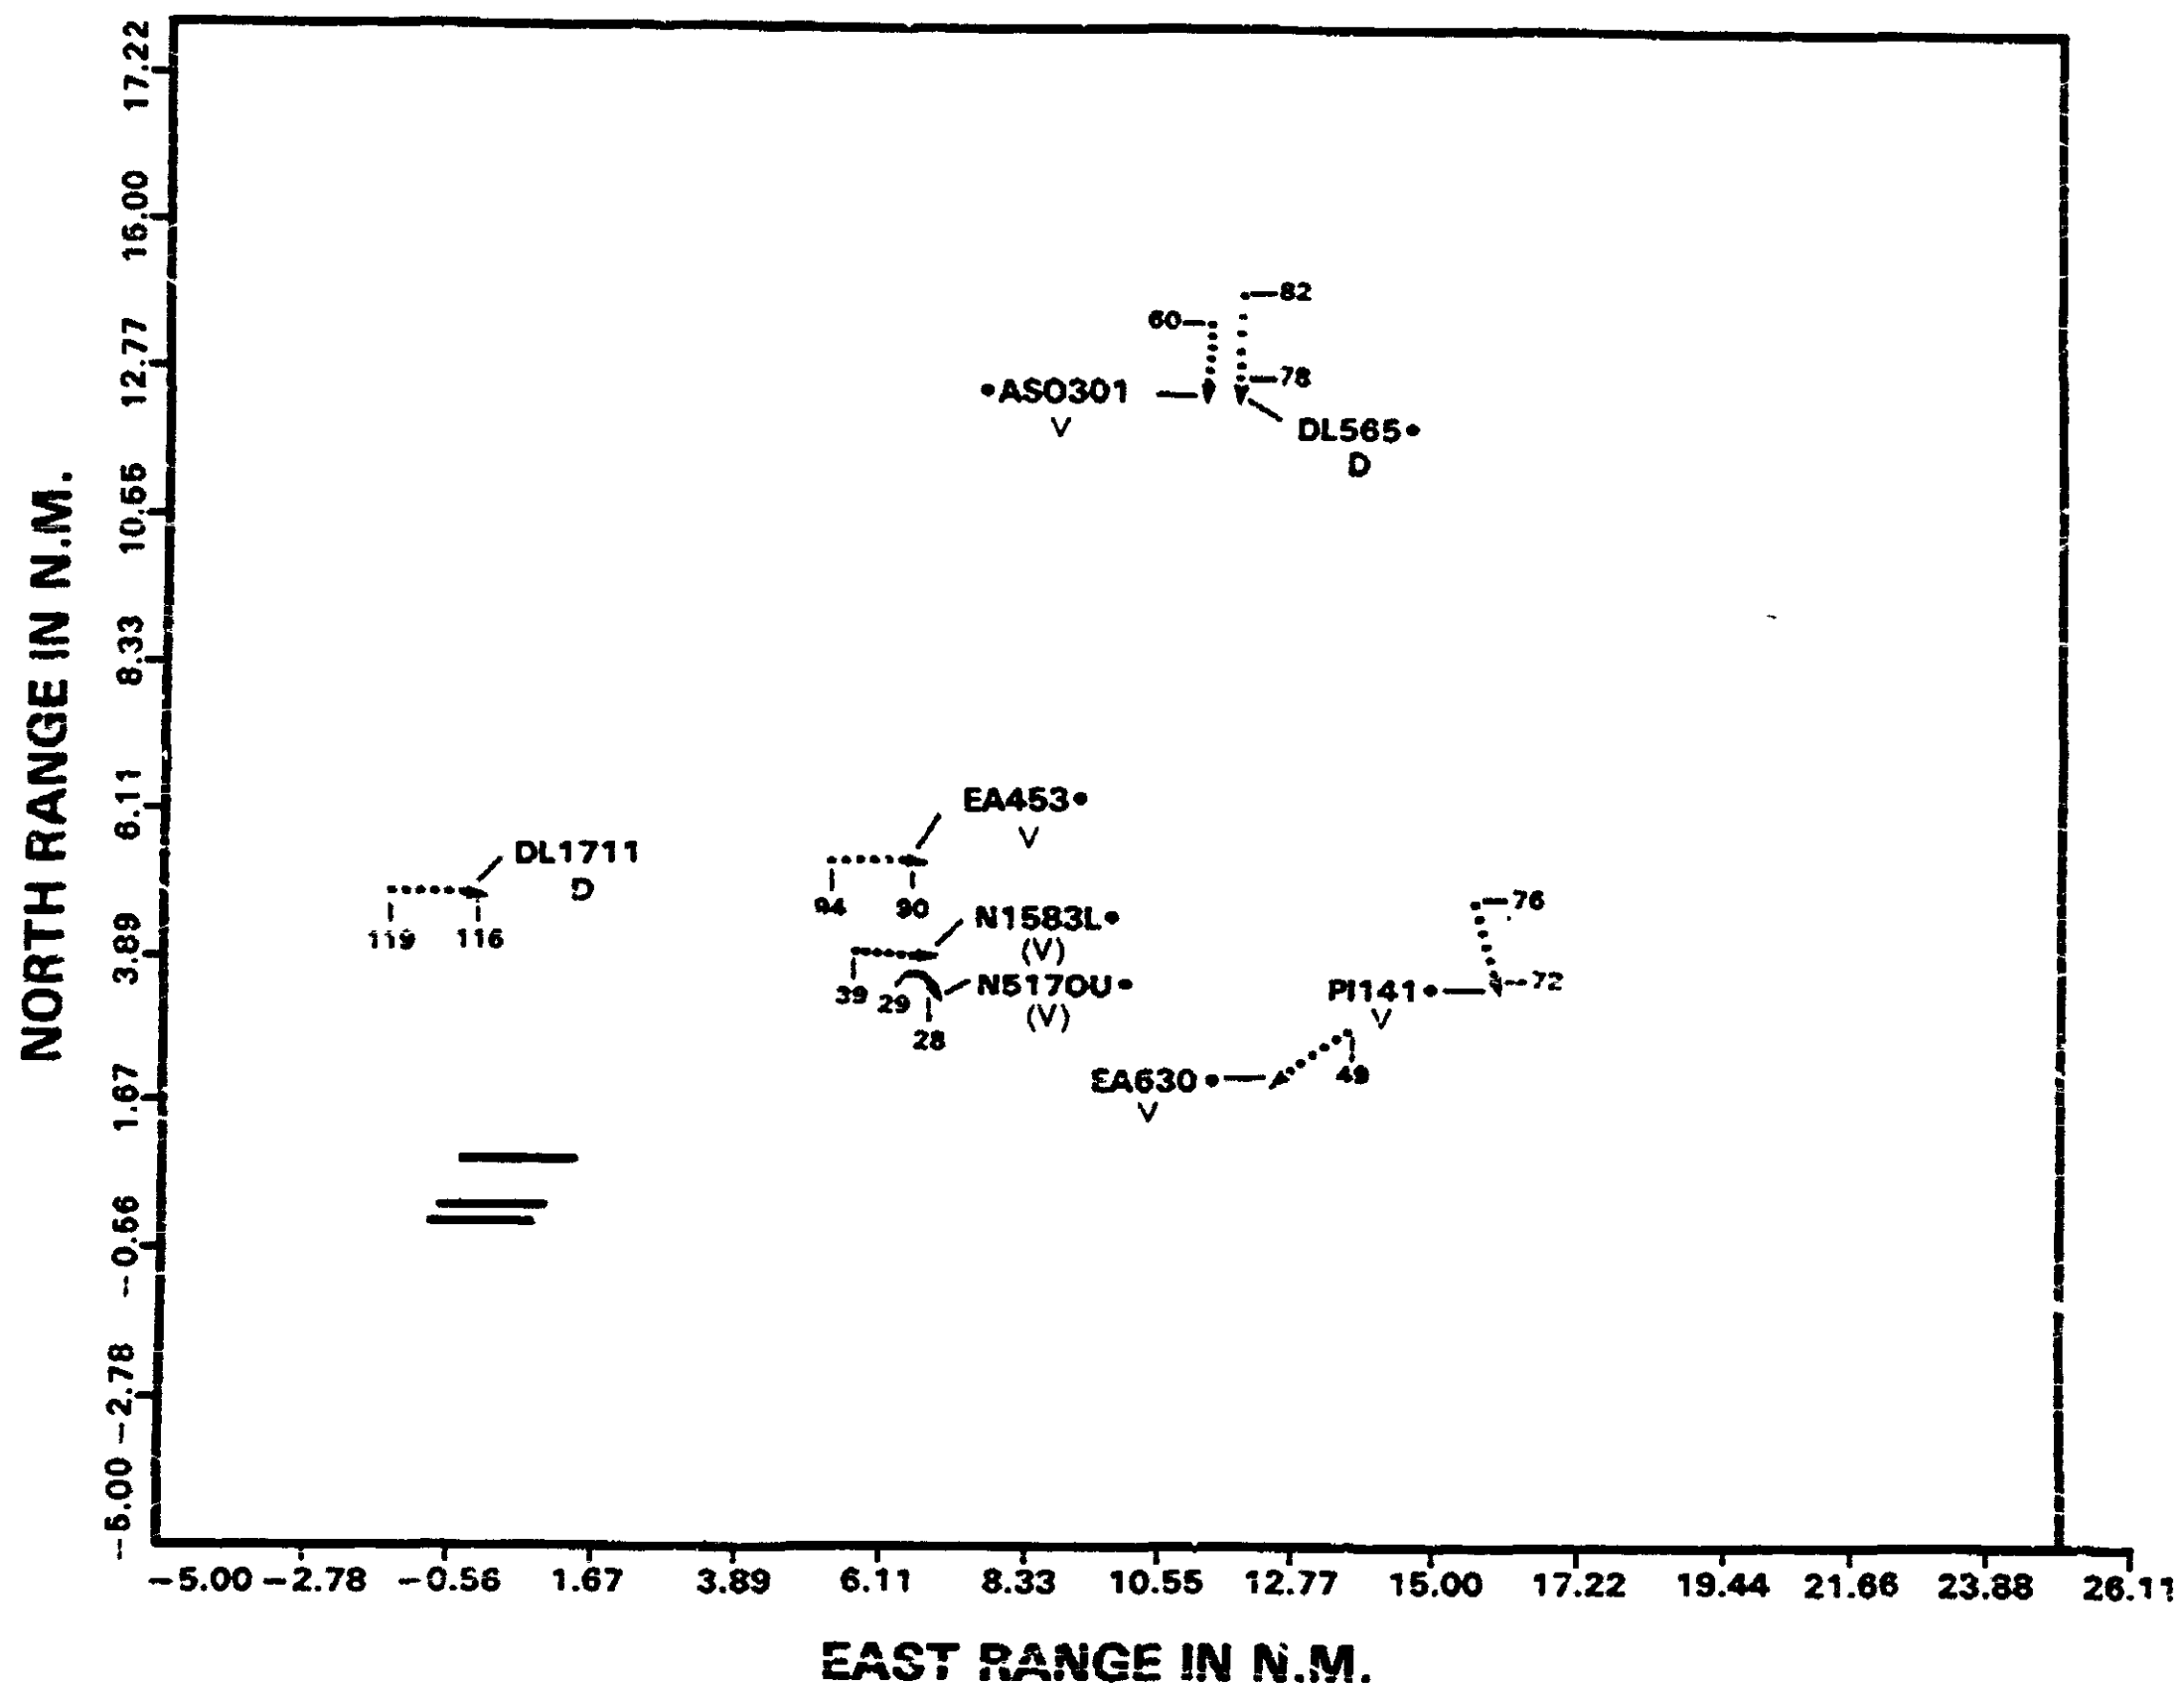
08:13:00.0-08:13:30.0

Because of the visual approach clearance issued to EA630, EA630 then asks the controller "what's our traffic."

The visual approach clearance without pointing out preceding traffic should be noted.

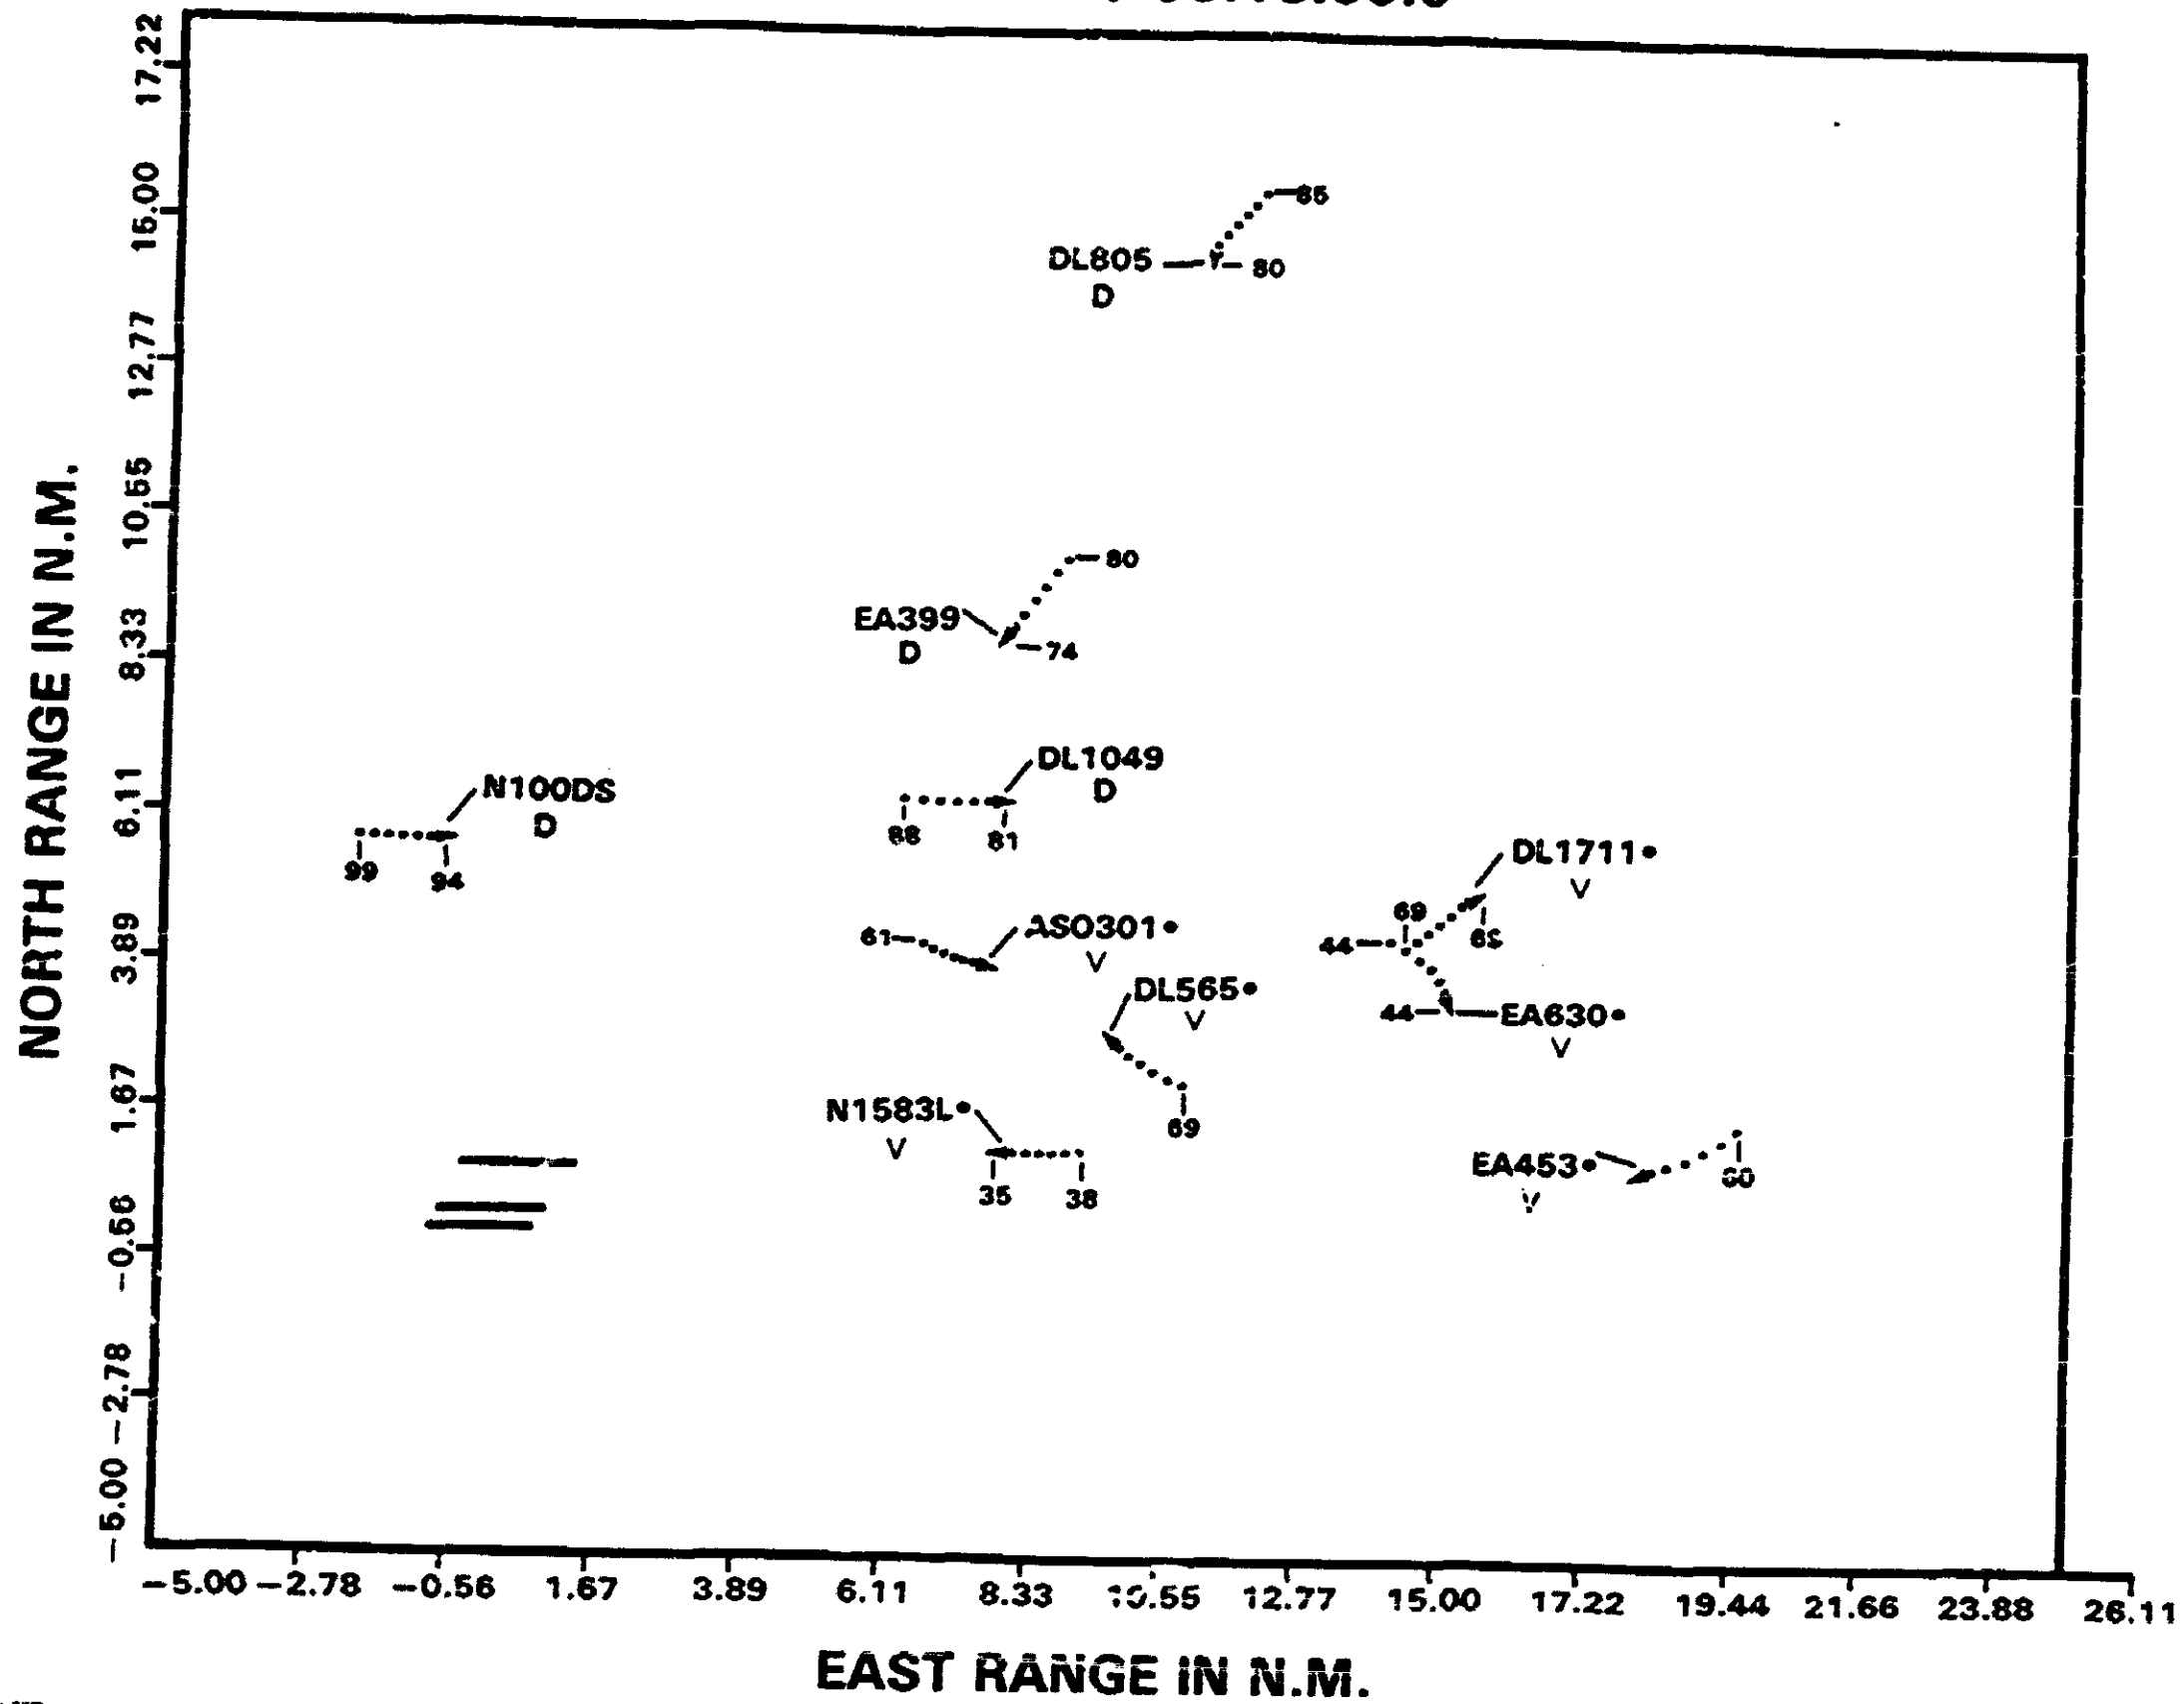
08:17:30.0-08:18:00.0

The feeder controller said that his first indication of any problem on the final radar position was when the supervisor told him to keep EA399. This most likely occurred before this (08:17:30 to 08:18:00) time frame. Neither the supervisor nor the feeder controller knew of the conflict between EA453 and DL565 which occurred at 08:15:00.0 at an altitude of 7,000 ft. Again, it should be noted that the final controller normally controls altitudes of 5,000 ft and below.

EA399 and DL1049 came within 500 ft and 2.16 nmi of each other. It should be noted however, that at this point their courses are diverging and there was no conflict alert.
